22kV Cable Termination Failure at Switchgears and Transformers - A Common Cause of Voltage Dip in Singapore

By Lee Wai Meng J. M. PANG & SEAH (PTE) LTD

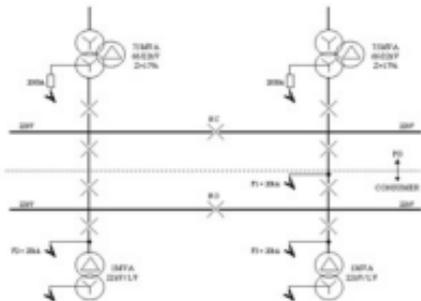
Therefore a fault of F1 and F2 is almost equivalent to a three-phase fault at the terminal of the PowerGrid 66/22kV transformer and is almost independent of cable length and impedance of customers transformers. Hence a customer with a small 1MVA, 22kV/400 Volts transformer can cause a voltage dip of similar magnitude as another customer with a large 20MVA, 22/6.6kV transformer.

Figure 1 illustrates a typical connection between a 22kV customer and PowerGrid. Fault F1 is mainly at the 22kV cable termination of the customer incoming switchgear. Fault F2 is either at the 22kV cable termination of the customer outgoing switchgear or at the 22kV cable termination of the transformer cable box. Most faults are phase to earth and because of the confined space in the transformer cable box and switchgear, the earth fault will invariably lead to a three-phase fault. The magnitude of the 22kV three phase fault current will be largely determined by the impedance of the PowerGrid 66/22kV transformer. The impedance of the 22kV cable between PowerGrid and the customer is not large enough to

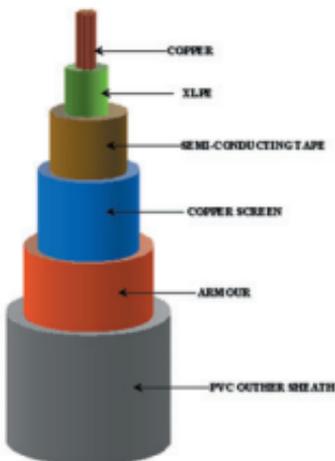
An understanding of the causes for the premature failure of heat shrink cable terminations will need a basic knowledge of the construction of cables. Figure 2 illustrates the various layers of a common 22kV XLPE insulation cable. The copper screen and the semi-conducting screen are the most important layers with respect to the heat shrink cable termination.

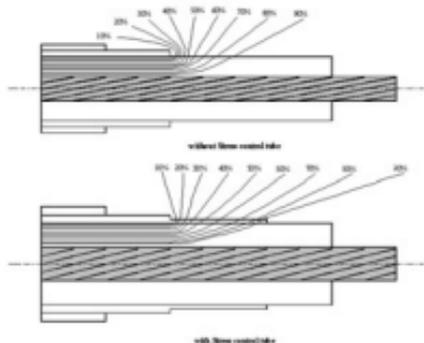
Figure 4: Lines of electric field

Figure 4 illustrates the difference in the lines of electric field for a cable with and without the stress control tube [3]. The use of incorrect length of stress control tube is one of the common cause of premature failure of cable termination.

- The length of the stress control tube must be suitable for the operating voltage of the cable termination. For the existing electrical installations, the length of the stress control tube can be easily measured by visual location of the start and end sections of the stress control tube. In any shutdown maintenance, such measurements is strongly recommended. I have found many 22kV electrical installations with 190mm length stress control tube used in the common 22kV 3 core cables. The 190mm length stress control tube is more suitable for 11kV operating voltage.
