Busbar 22kV GIS

Asset:	Busbar of 22kV GIS
PD sensor:	Ultrasound from different OEM

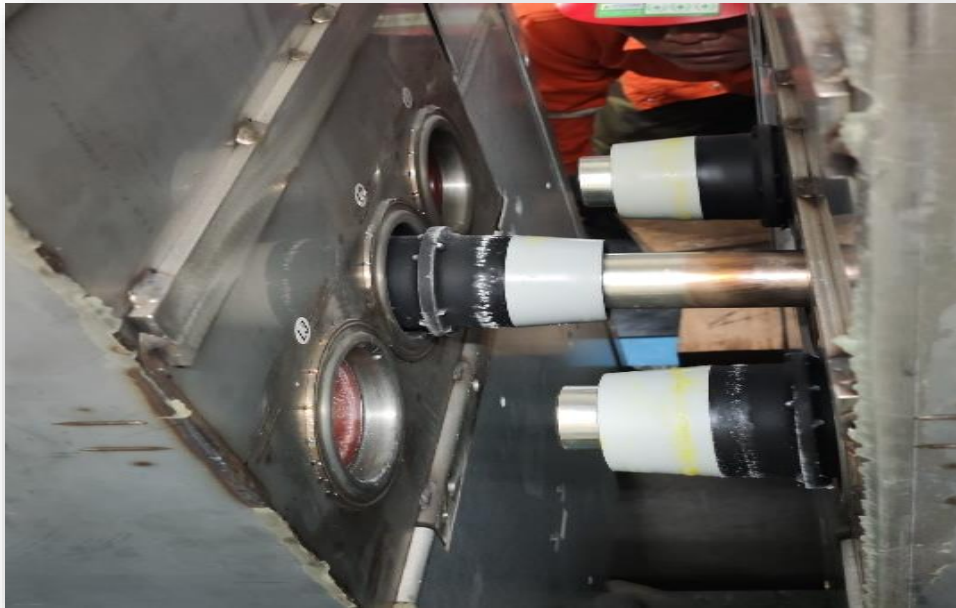
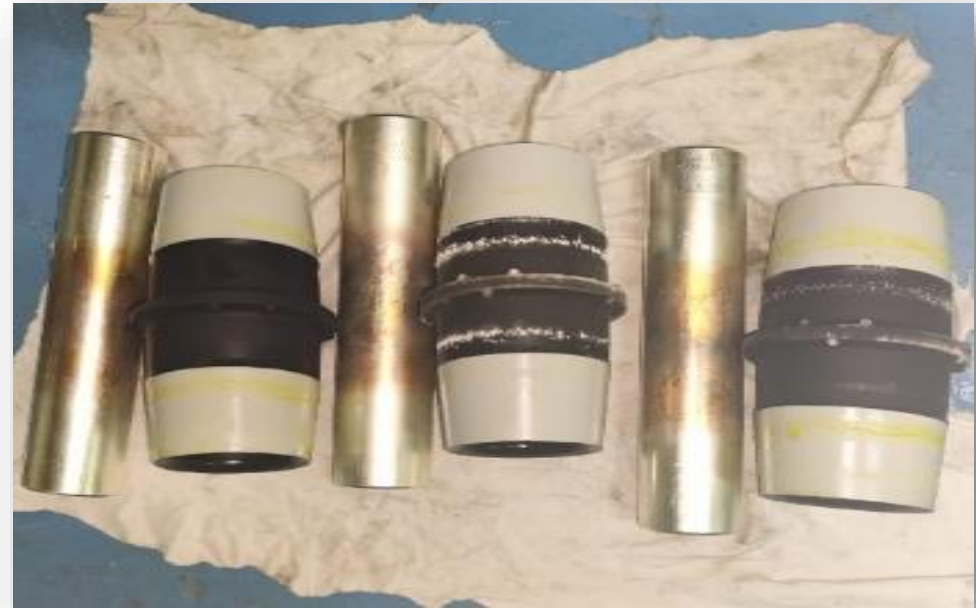
Visible discharge busbar of GIS

09 March 2023	GIS was de-energized. Surface discharge was found at busbar connectors between bus coupler and bus riser.
---------------	---

11 March 2023	No abnormal ultrasound was detected after replacing the busbar connectors.
---------------	--

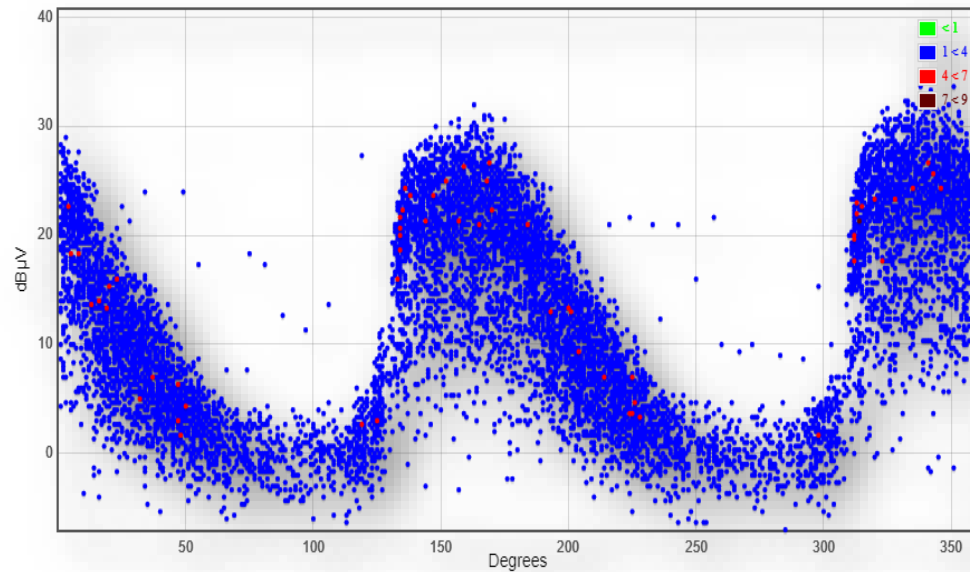
03 March 2022	PD activity was detected at the 22kV GIS during routine online PD measurement.
---------------	--

Abnormal ultrasound

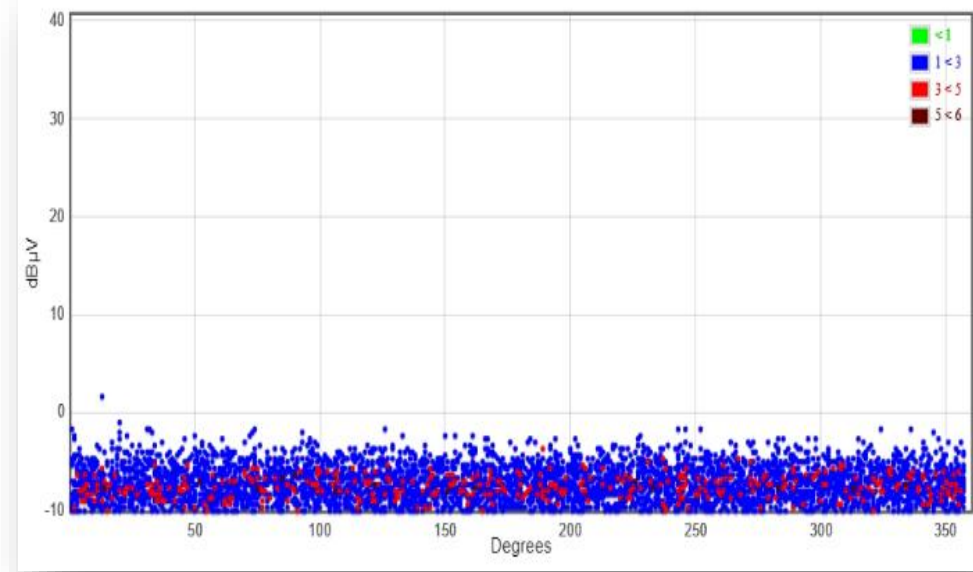
No abnormal ultrasound after replacing of busbar connectors

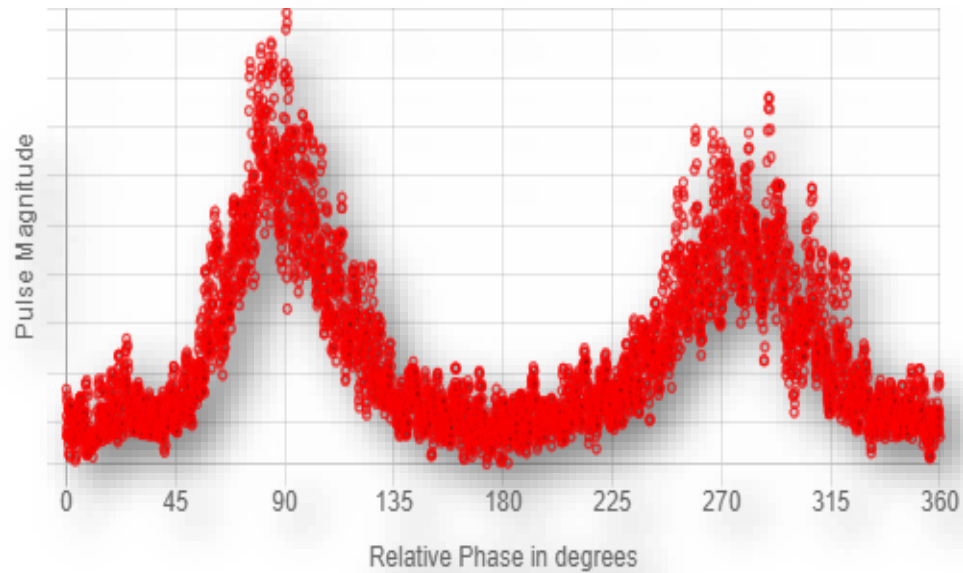
Abnormal ultrasound

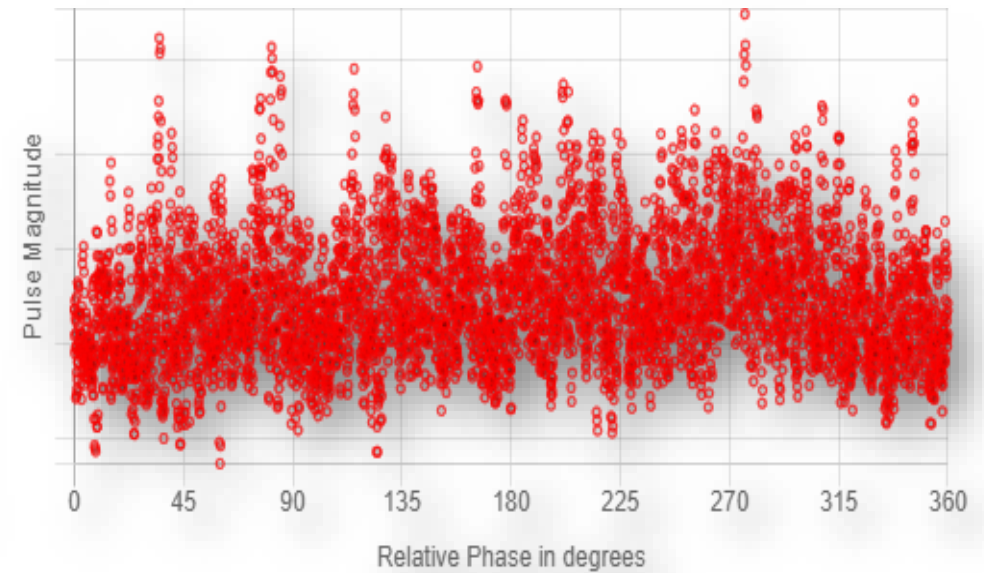
No abnormal ultrasound after replacing of busbar connectors
